# Eastleigh Hydrological Sensitivity Study

Task 1

Revised Report

May 2018

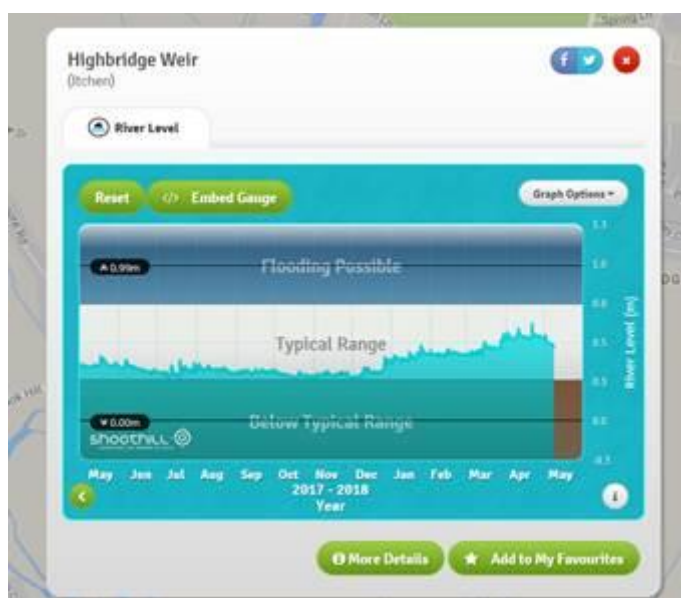
Figure B1 - Highbridge Weir Water Levels on the River Itchen<sup>17</sup>

Spot flow gauging was carried out over a one-day period to provide an estimate of flows within the lower Itchen tributary watercourses over which the proposed NBLR lies. This was undertaken in order to address comments from the EA which sought to better understand ground and river conditions following a period of significant / prolonged rainfall. Conditions were originally observed in June 2017 followed prolonged dry weather. Whilst the weather at the time of the visit in May 2018 was dry, high rainfall during the spring led to relatively high water levels observed at the gauged Highbridge location on the Itchen, as per Figure B1.

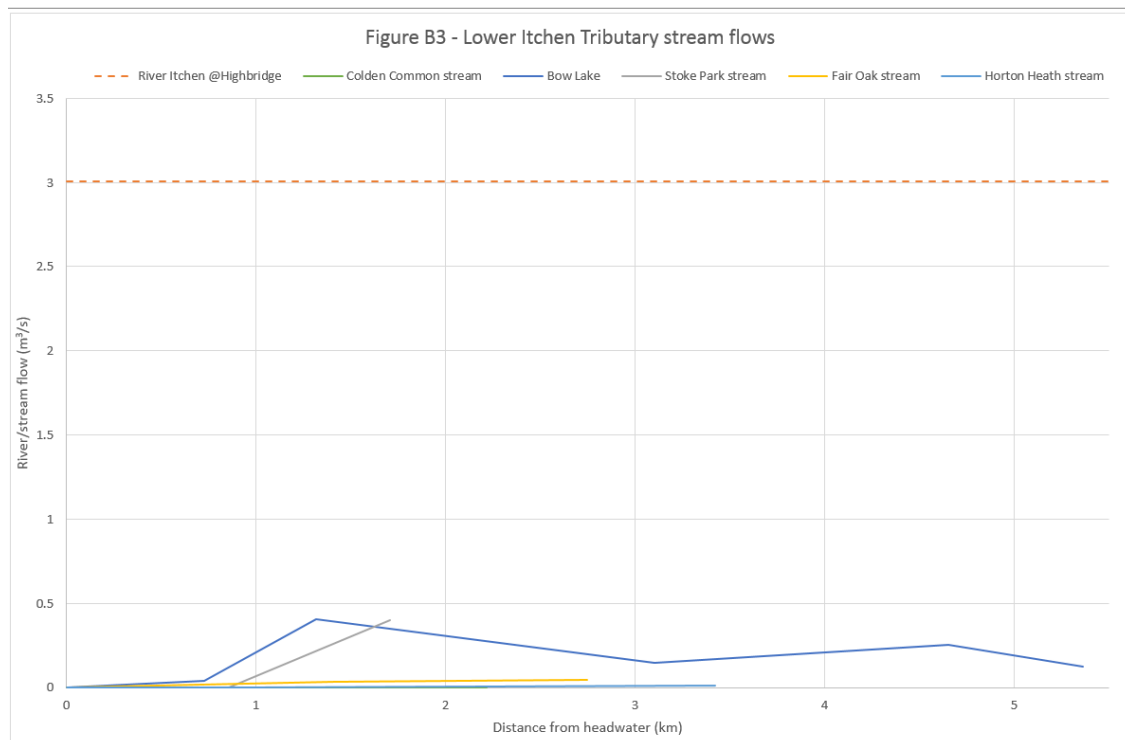
Figure B4 - Lower Itchen Tributary Stream Flows

An accretion profile of the flows at individual flow observation points with distance from the headwater location on each watercourse has been plotted in comparison to these Q95 Itchen flows, in Figure B4.

The profiles indicate that the watercourses do not necessarily gain water steadily along its reach. However, the signal may in part reflect factors like faster flow rates occurring through a culvert<sup>20</sup>, errors in estimating flow in culverts, flow inputs from pumping stations, and inaccuracies in estimation of channel width or reach length.

It is noted that the high value at Bow Lake 2 location is likely skewed by the lake discharge occurring immediately upgradient of the flow observation point. Bow Lake sites 3 and 5 occur immediately upgradient of a mapped pumping station, and data are not available here to evaluate the contribution these make to flows. However, it appears that the changes in flow due to these pumping stations are sufficiently large to be higher than the total flow at the headwaters.
