Eastleigh Hydrological Sensitivity Study: Geomorphology and Ecology Assessment

Final Report

June 2018

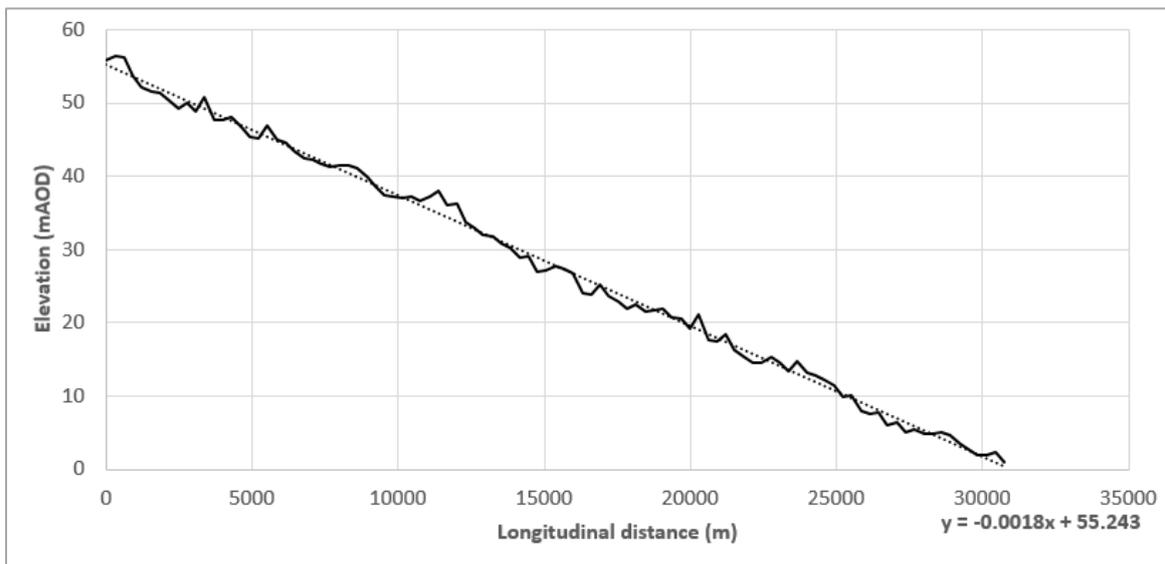
Figure 3-3: Gradient of the River Itchen

An approximate channel long profile has been extracted from the EA Terrain OpenData (50m grid resolution). This has been extracted from the upstream extent of the River Itchen operational catchment to the downstream extent at Southampton. The long profile is shown in Figure 3-3. The gradient is low throughout the catchment, with a value of 0.002.

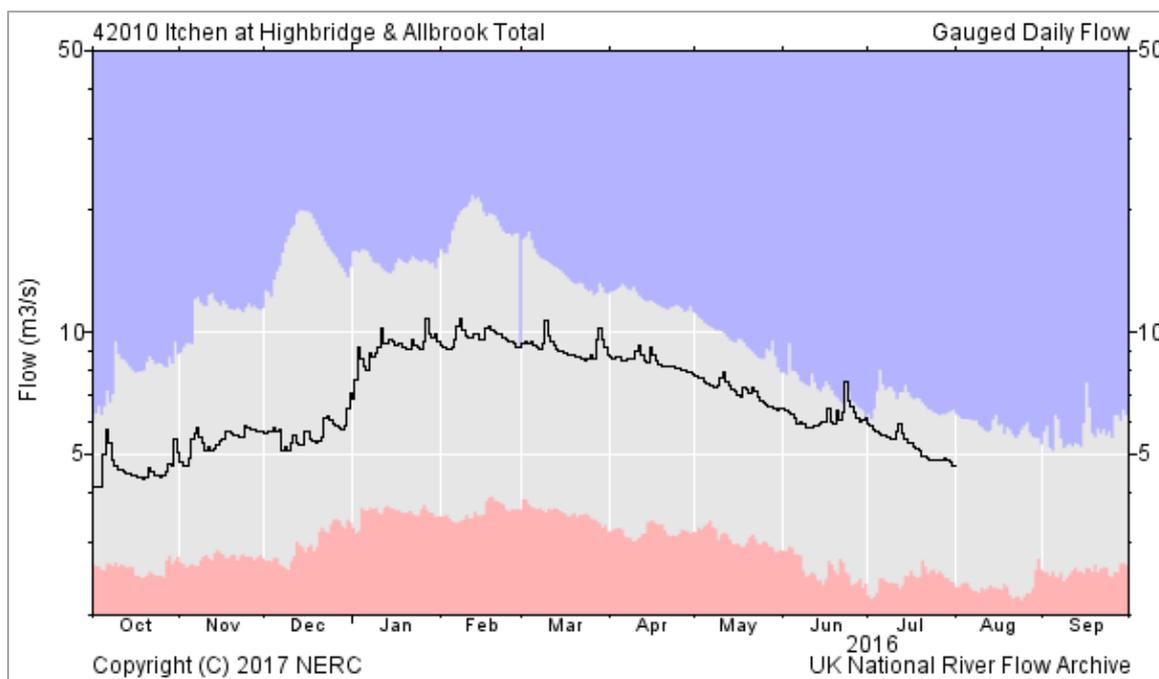
Figure 3-4: Gauged daily flow for the River Itchen at Highbridge & Allbrook

The River Itchen is gauged at Highbridge, just upstream of the study site. Figure 3-4 shows the annual hydrograph from 2016 at Highbridge. The red and blue envelopes represent the lowest and highest flows on each day over the period of record. The annual hydrograph illustrates the relatively stable flow regime. Chalk rivers are characterised by a baseflow dominant flow regime: the slow release of water from the aquifer attenuates rainfall events, providing a steady flow regime with a characteristic cycle. A strong seasonal signal is evident with baseflows reducing significantly during the summer months. If the aquifer and land are saturated, some rainfall events can induce a more rapid response or where there are areas of impermeable deposits over the Chalk.

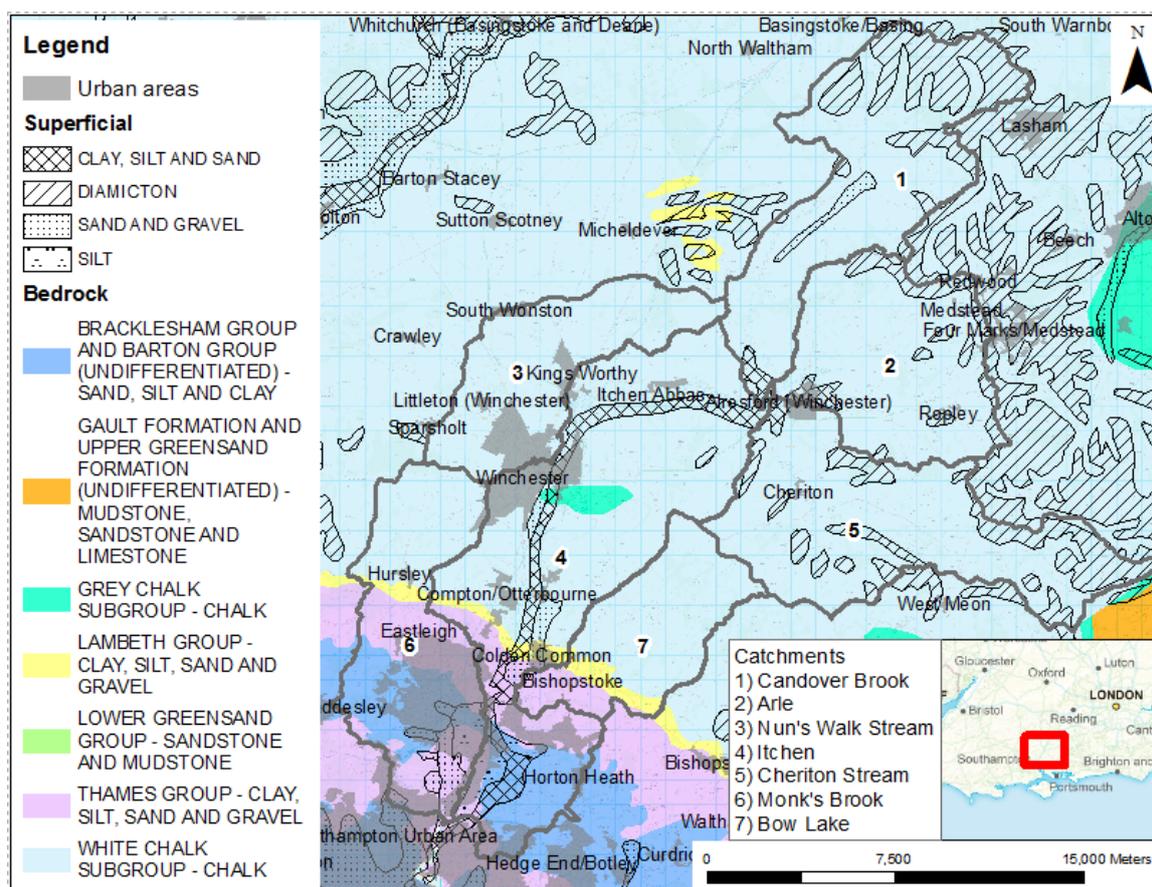
Figure 3-5: Bedrock and superficial geology within the catchment

The River Itchen catchment is underlain by chalk in the north (Figure 3-5). In the lower areas to the south of the catchment, clays, sands and gravels of the Tertiary deposits overlie the chalk. The junction at which these Tertiary deposits begin, runs from Bishops Waltham in the east to Salisbury in the west. These units are relatively impermeable which causes rapid run off into the Itchen and their tributaries in these areas (Environment Agency, 2012)². Superficial deposits are concentrated in river valleys, where alluvial sediments have been deposited.

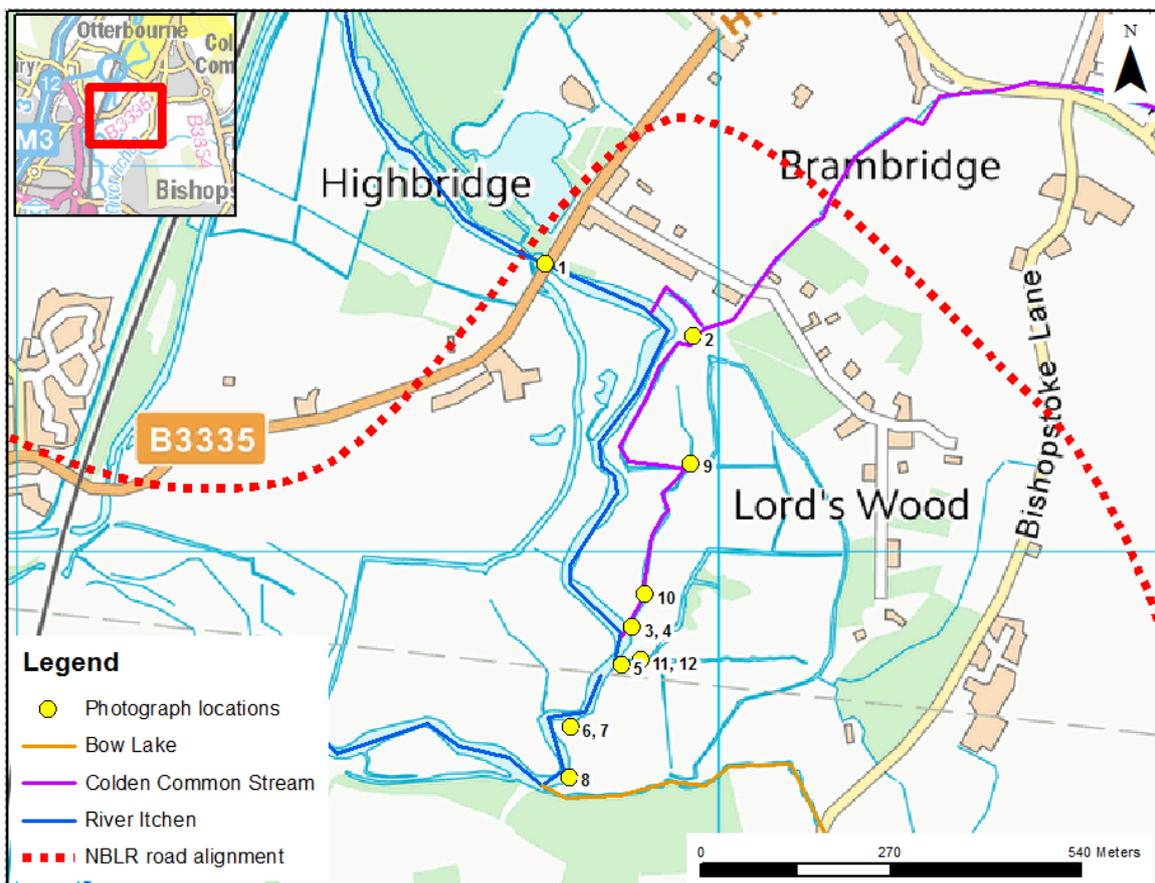
Figure 4-1: River Itchen and tributaries in the vicinity of Lord's Wood. Labelled points relate to the location of the photographs presented in Figure 4-2 and Figure 4-3.

The walkover survey focussed on the River Itchen to the west of Lord's Wood (Figure 4-1). This area contains a complex of drains and small tributaries which feed into the River Itchen. The proposed NBLR alignment crosses the north of the existing road bridge, however, access to this area was not permitted, therefore the walkover survey examined the Itchen floodplain downstream of the road bridge, which has a number of public footpaths crossing the site.

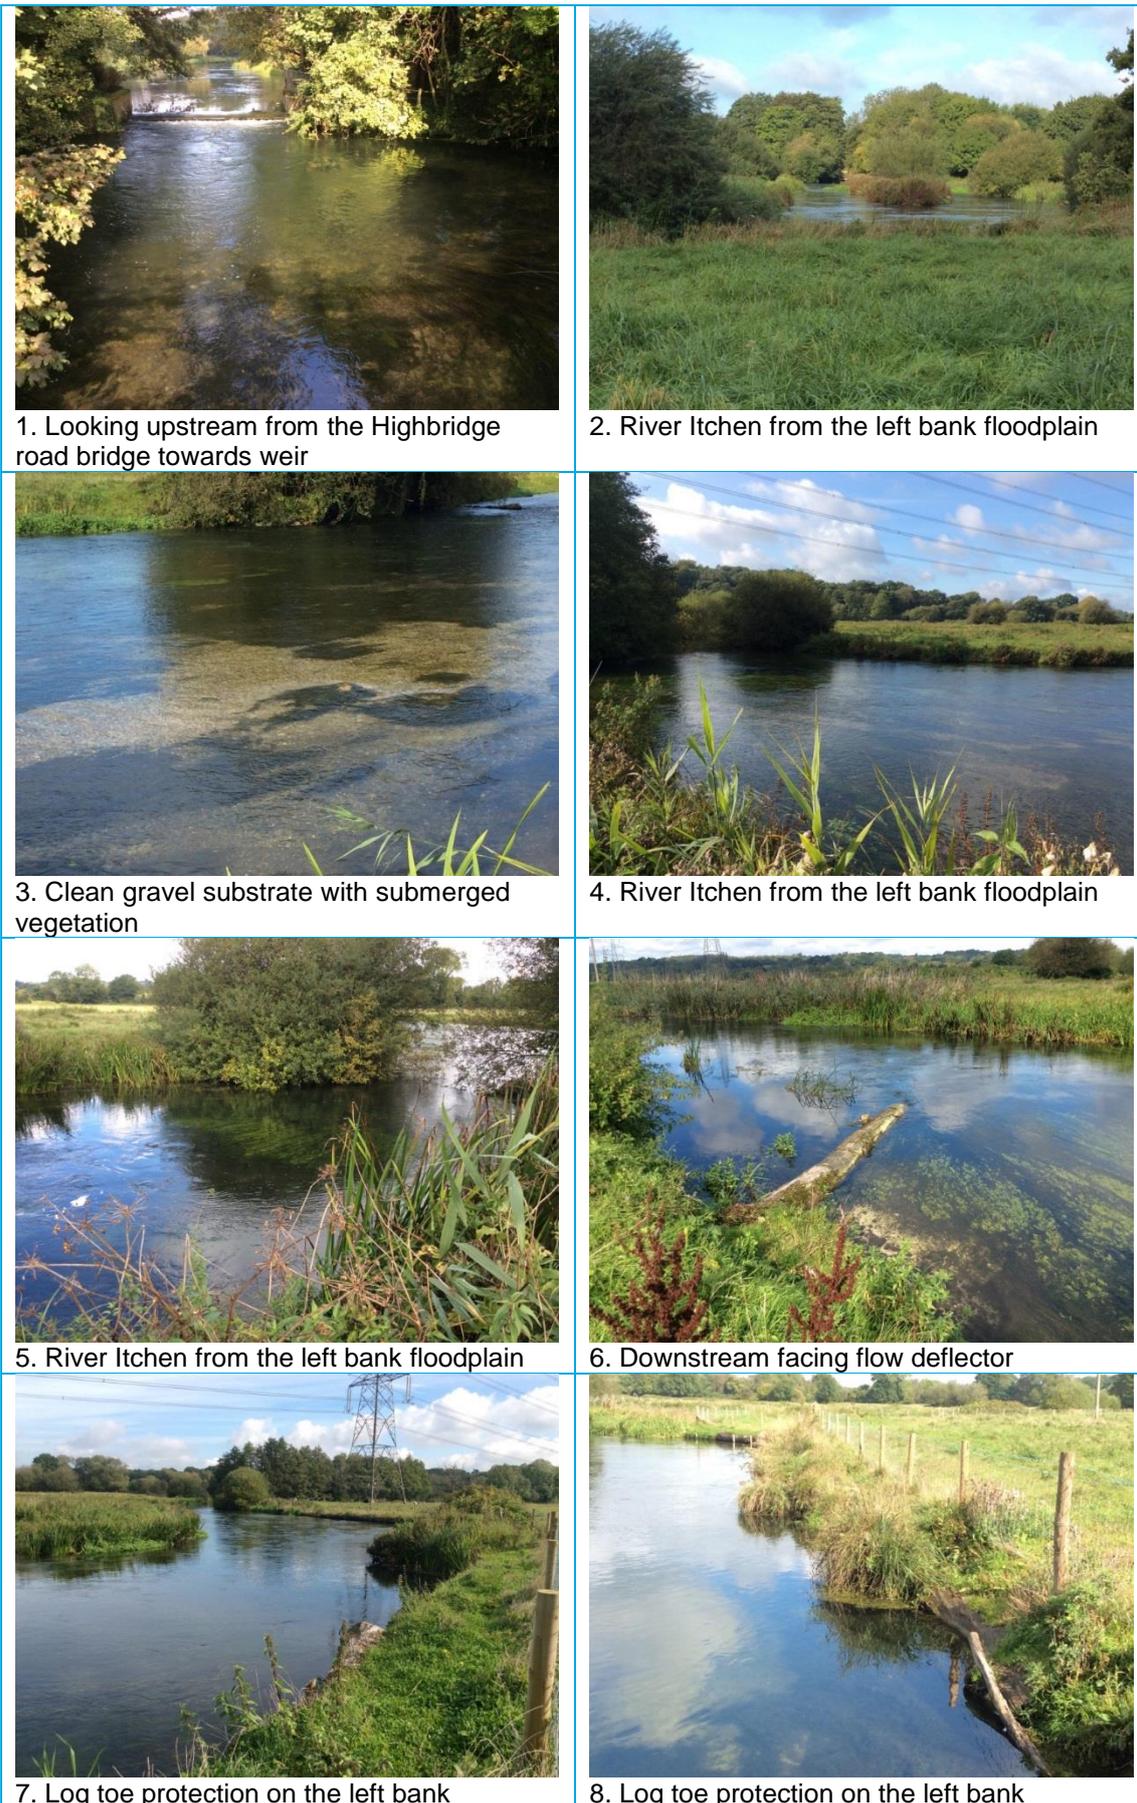
Figure 4-2: Photographs of the River Itchen in the vicinity of Lord's Wood

The channel is exhibiting chalk stream characteristics, with a clean gravel bed and an abundance of in-stream vegetation. Flows through the survey extent were characterised by long glides, and a lack of riffled sections. There were no exposed gravel bars, although the clarity of the water meant that it was possible to observe the bed, which displayed elevation heterogeneity with accumulations of gravel on the inside of meander bends as well as mid-channel submerged bars. The channel was well-connected to the floodplain through the reach.

Bank restoration works, in the form of a log toe, and fencing appear to have been installed recently, presumably to counteract livestock poaching. The fence line has been set-back from the channel, but there is relatively little in terms of riparian vegetation. A downstream facing flow deflector has also been installed to provide flow diversity within the reach. This is trapping gravels on the upstream face and reducing channel width to encourage a more sinuous flow path.

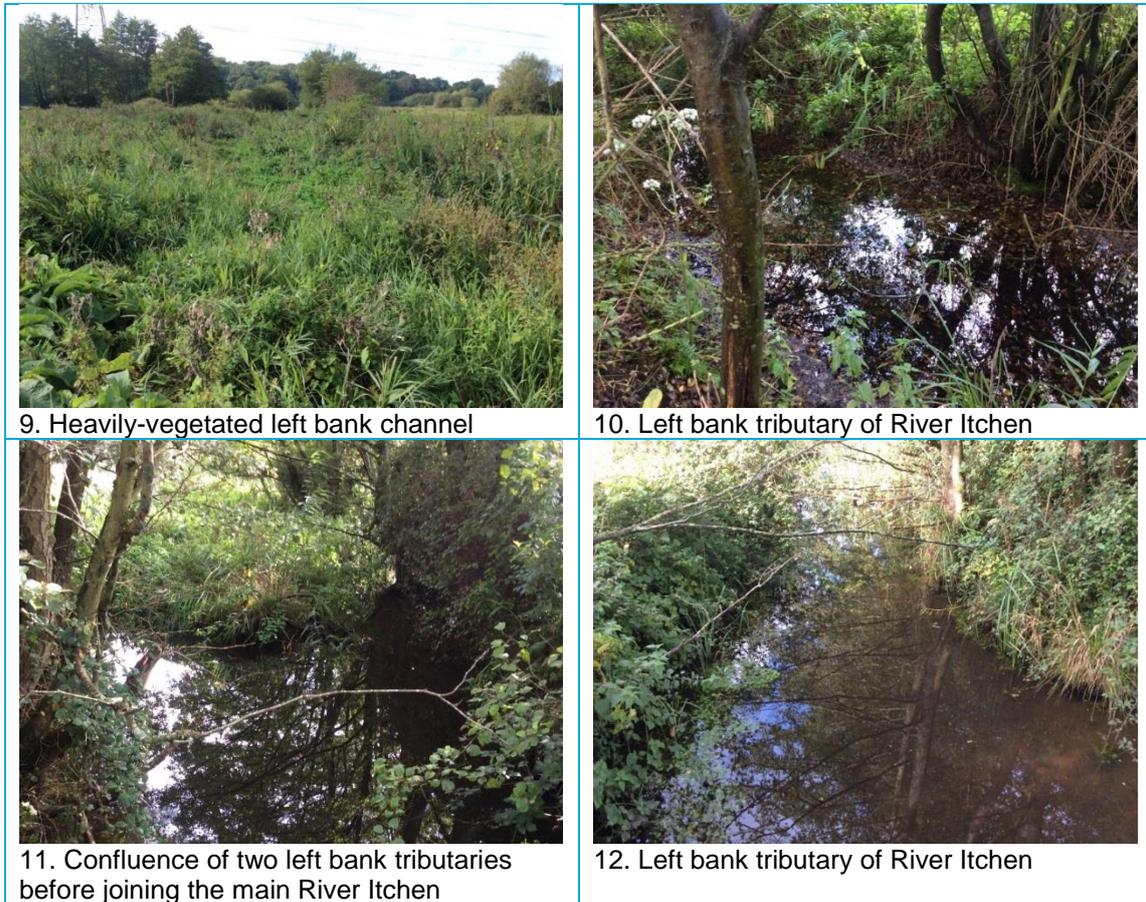
Figure 4-3: Photographs of tributaries of the River Itchen in the vicinity of Lord's Wood

The various channels joining the River Itchen on the left bank were found to be displaying standing water in most instances, with a bed substrate of organic material (Photographs 9-12).

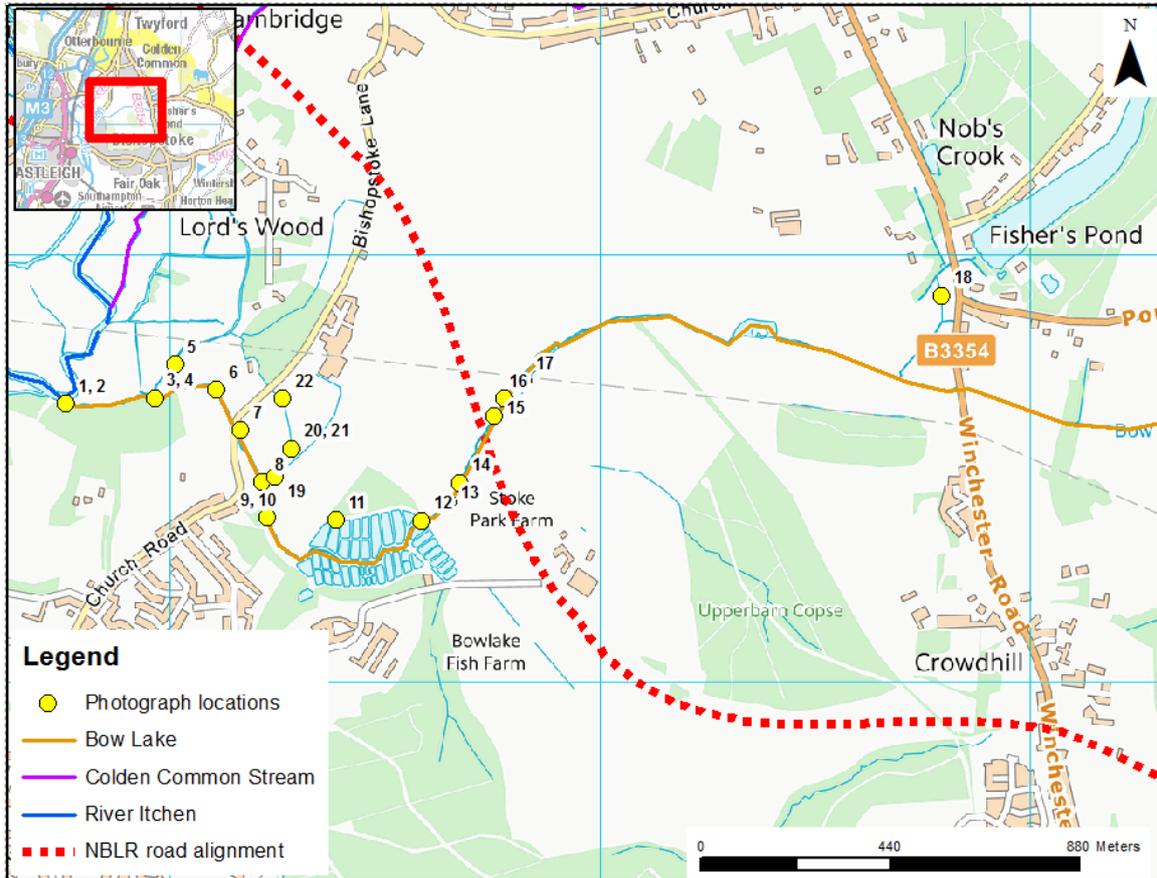
Figure 4-4: Bow Lake and tributaries in the vicinity of Lord's Wood. Labelled points relate to the location of the photographs presented in Figure 4-5.

The walkover survey focussed on the Bow Lake to the south and east of Lord's Wood (Figure 4-4). This reach includes small tributaries which feed into the Bow Lake on the right bank.

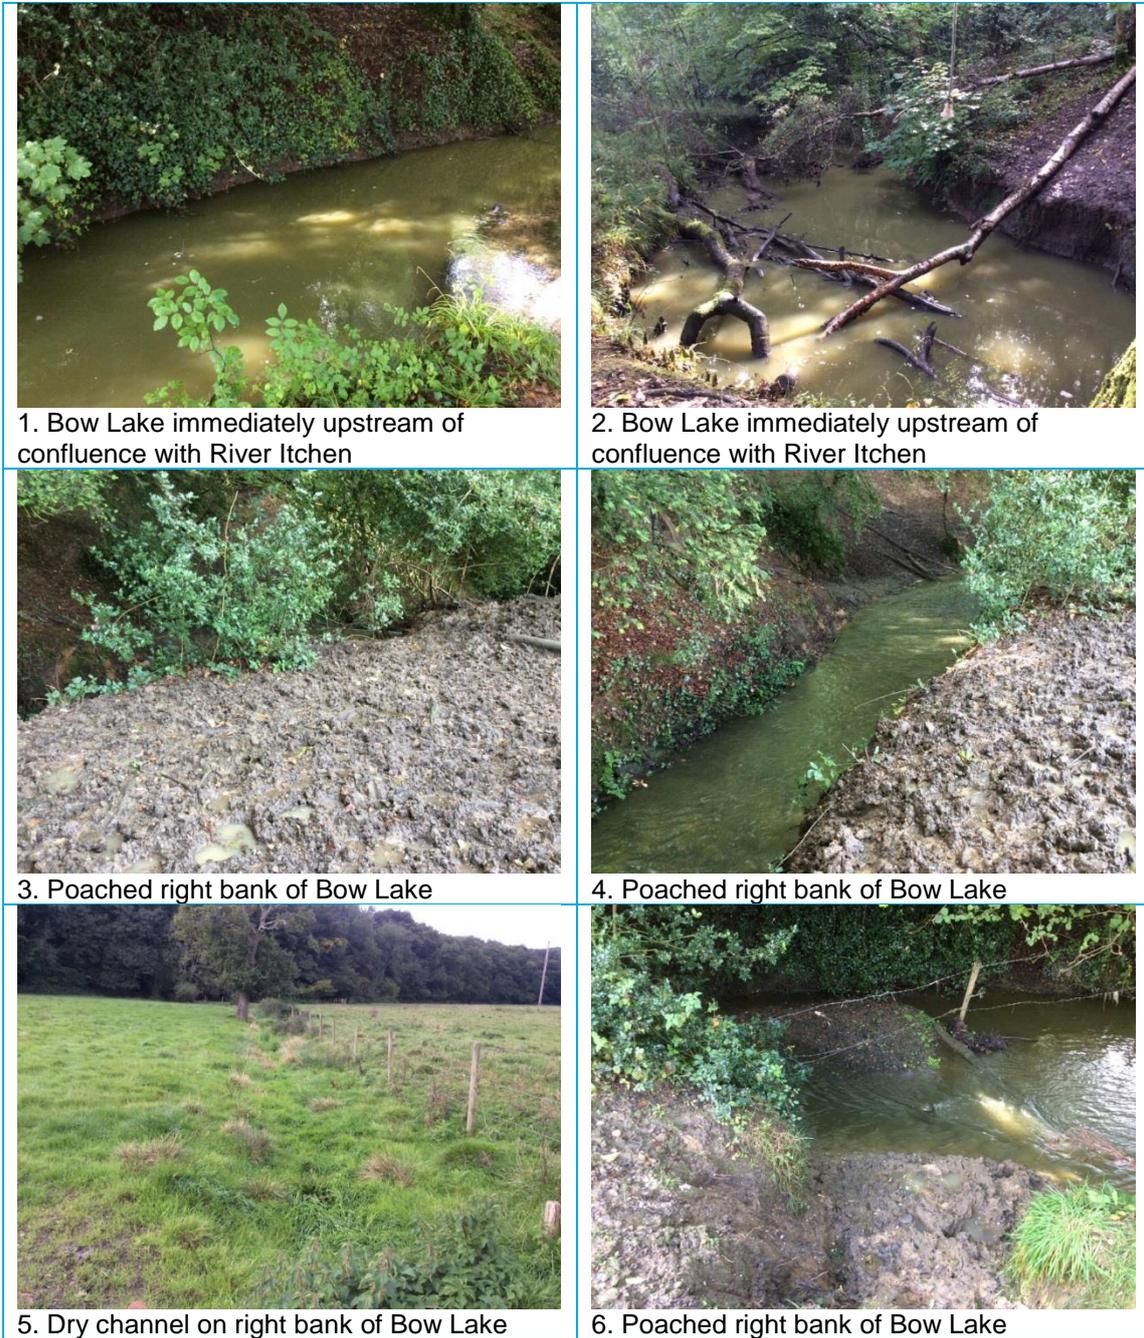
Figure 4-5: Illustrative photographs of Bow Lake and tributaries: locations are shown in Figure 4-4

There is a stark contrast between the clear waters of the River Itchen and the turbid waters of the Bow Lake, its left bank tributary. The Bow Lake has high levels of suspended sediment within the water column, obscuring the view of the bed (Photos 1 and 2).

Ground on the left bank rises sharply away from the channel and is densely wooded. The right bank is fenced, however in places this is broken / missing, and consequently, the ground is heavily poached right up to the edge of the channel, with sections of vertical, exposed banks, devoid of vegetation (Photos 3, 4 and 6).

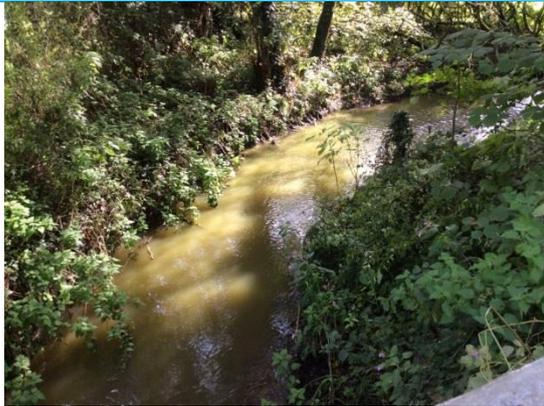
7. Turbid nature of Bow Lake

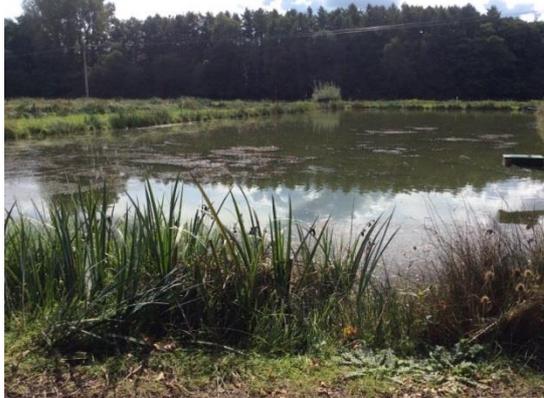
11. Bowlake fish farm

Bow Lake passes through a fish farm and Himalayan Balsam *Impatiens glandulifera* was noted to become apparent, and more dominant in this reach. Other species recorded in this reach included Branched Bur-reed and Reed Sweet-grass. The bank tops were dominated by treelines and hedges.

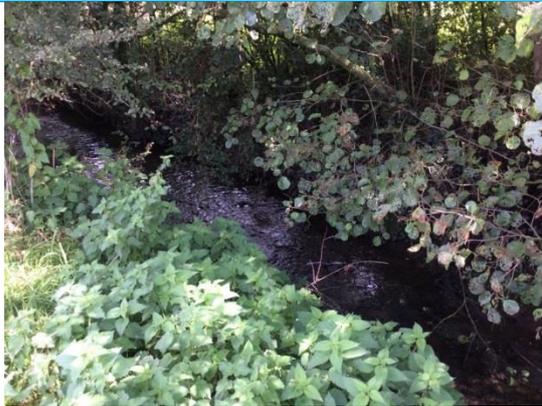
15. Riffle-type features

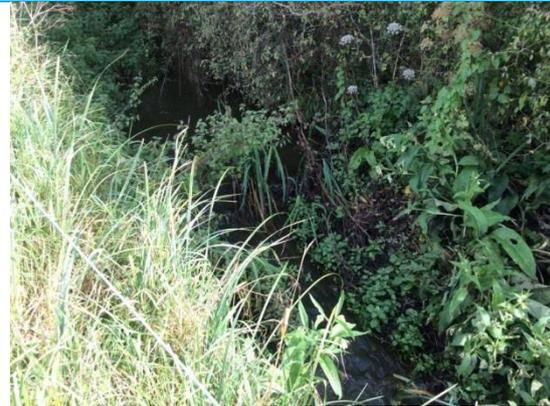
16. Bow Lake upstream of fish farm -
vegetation narrowing channel

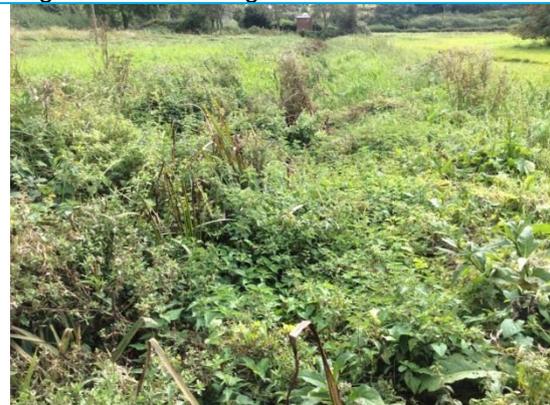
Further upstream, in the vicinity of the B3354 road, a tributary of the Bow Lake was examined. This was found to be a densely vegetated, drain like channel with no discernible flow (Photo 18).

18. Tributary of Bow Lake adjacent to B3354

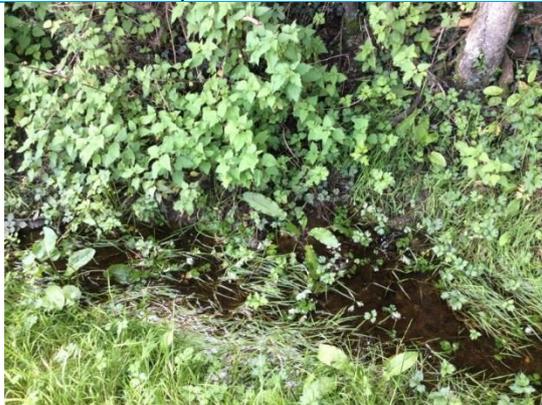
19. Ditch along field boundary

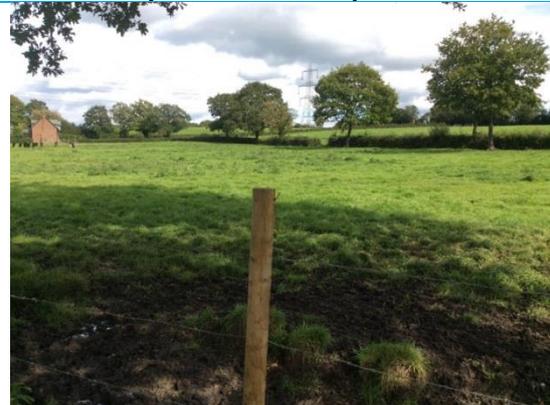
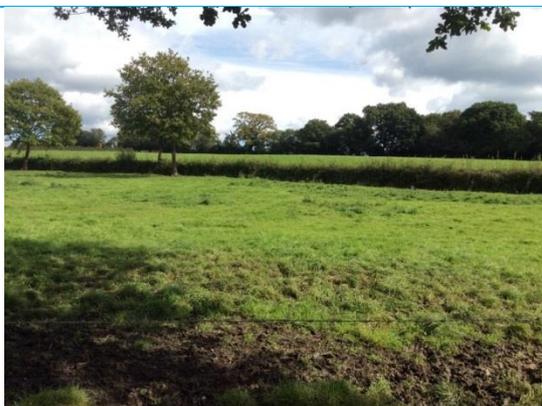
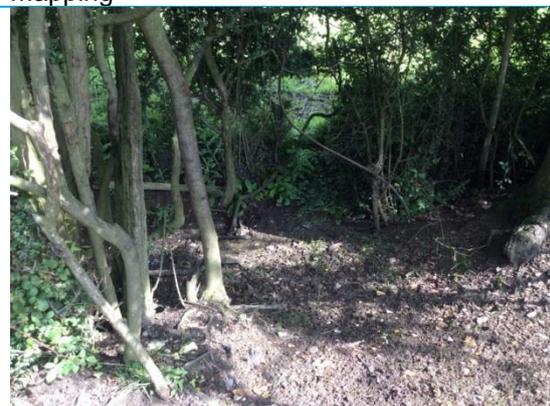
Other channels / drains that are indicated on mapping to join the Bow Lake from the right bank floodplain between the Bowlake fish farm and the water treatment plant were examined. Only one of these was found to contain a small amount of standing water, with the rest no longer existent (Photos 19-22).

20. Lack of drainage channels shown on
mapping

21. Lack of drainage channels shown on
mapping

22. Lack of drainage channels shown on
mapping

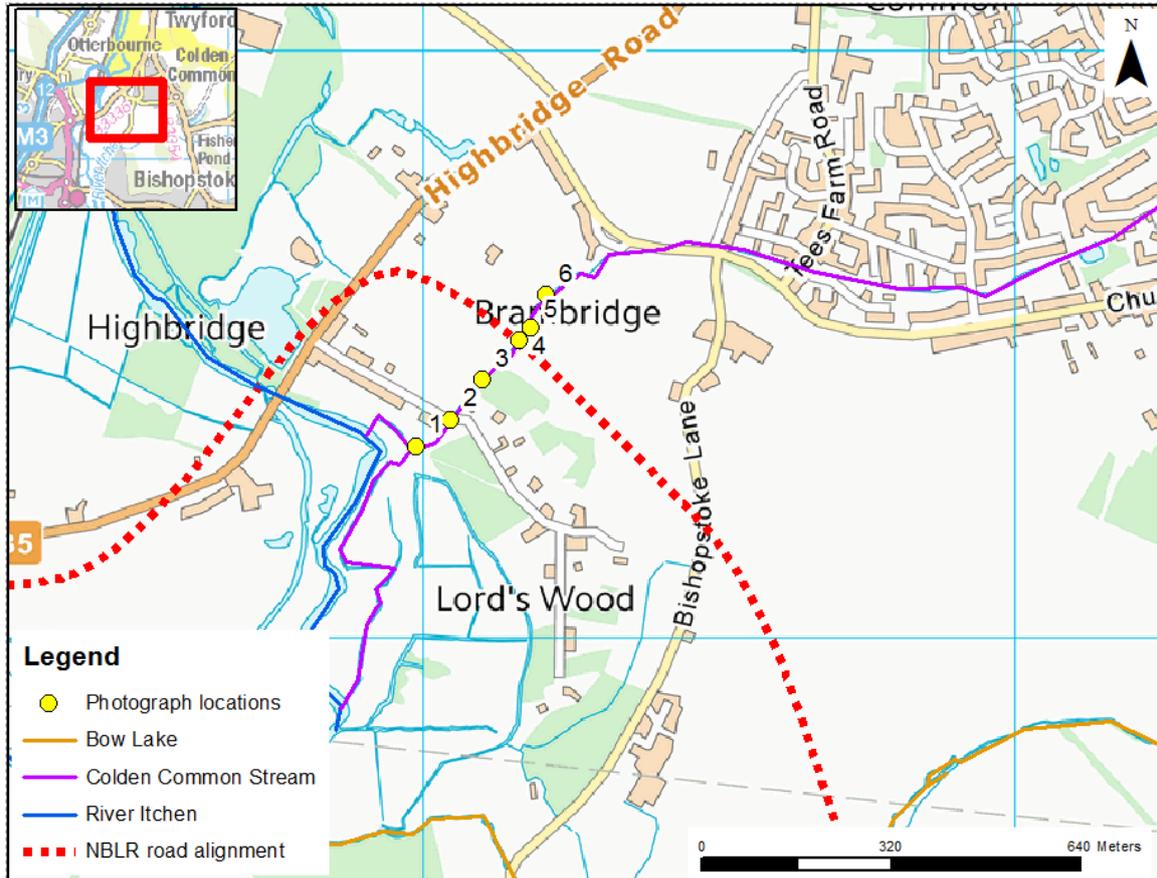
Figure 4-6: Colden Common Stream in the vicinity of Brambridge. Labelled points relate to the location of the photographs presented in Figure 4-7

The walkover survey focussed on the Colden Common Stream to the southwest of Colden Common (Figure 4-6).

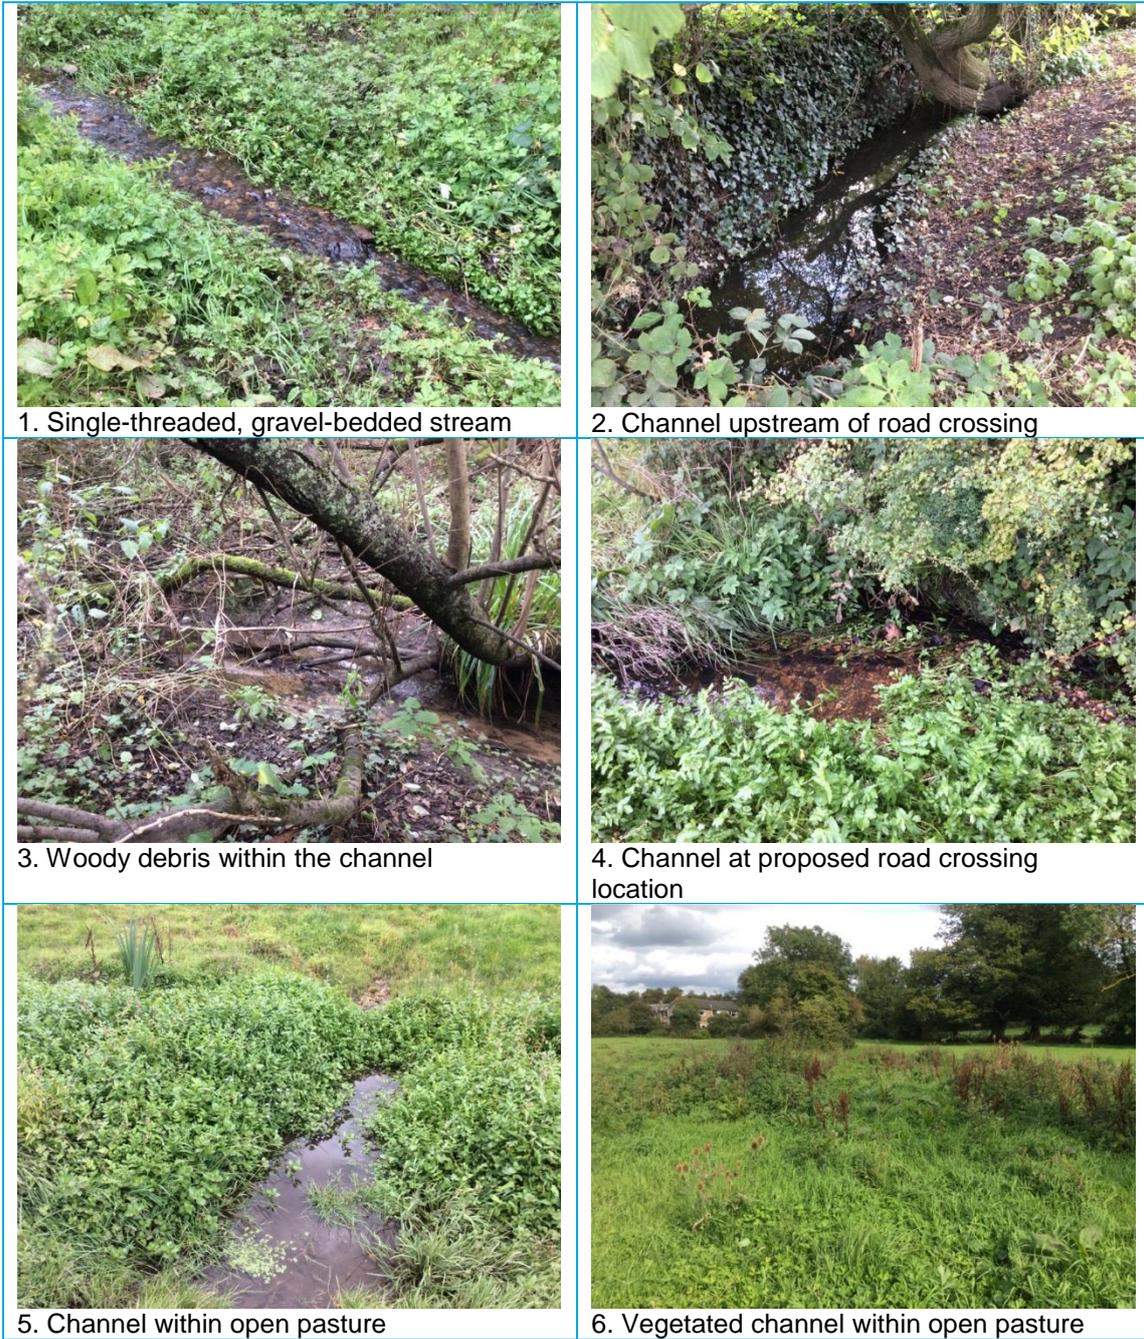
Figure 4-7: Photographs of the Colden Common Stream

The Colden Common Stream is a single thread, small, gravel-bedded stream (Photos 1 and 2). The channel is generally well-connected through the survey extent running primarily through pasture land and a small pocket of woodland adjacent to property (Photo 3). In the upper section of the survey extent, the channel is slightly poached as it runs through the pasture land (Photo 5).
