October 2018

The Highwood Group and Galliford Try Partnerships

EASTLEIGH STRATEGIC GROWTH OPTION

ALLBROOK APPRAISAL

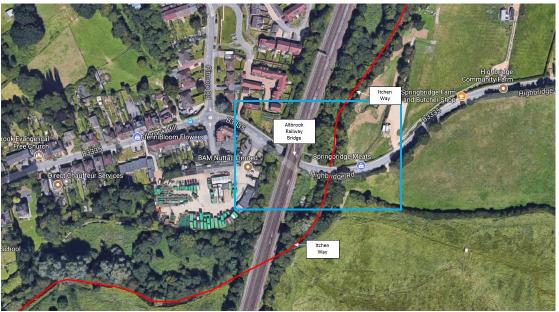
Figure 1: Allbrook Appraisal Study Area Focus

- 1.3 The focus of the study area is demonstrated in **Figure 1**, but consideration is given to the wider context and link road alignments.

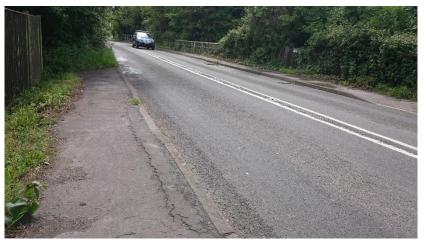
Photograph 1: Footways on Highbridge Road

2.38 At present, continuous footways of varied width (between c.1.3m wide and 1.7m wide) are in place on the northern side of the Highbridge Road carriageway from Allbrook Hill to 90m south of its junction with Wardle Road, after which the footway continues on the southern side of Highbridge Road into Colden Common, as demonstrated in **Photograph 1**.

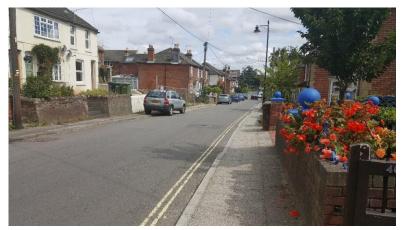
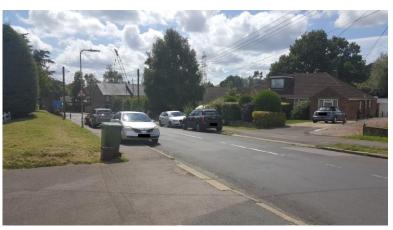
Photograph 2: Footways on Allbrook Hill

2.39 To the west of Allbrook Railway Bridge continuous footways measuring 1.3m in width are in place on both sides of the carriageway to Allbrook Hill, after which they continue on the southern side of Allbrook Hill only to the Allbrook Hill/ Allbrook Way/ Woodside Avenue roundabout or up Pitmore Road where footways measure between 1.5m and 1.8m in width. The footways on Allbrook Hill and Pitmore Road are demonstrated in **Photograph 2** and **3**.

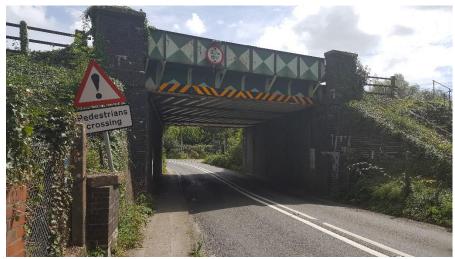
Photograph 5: Conditions under Allbrook Railway Bridge (view from the West)

2.40 Allbrook Railway Bridge itself is 17m in length and the current footway varies in width between 1.28m and 1.43m on just the northern side, with the narrowest point of 1.28m on the eastern side of the bridge. Allbrook Railway Bridge conditions are demonstrated in **Photograph 4** and **5**.

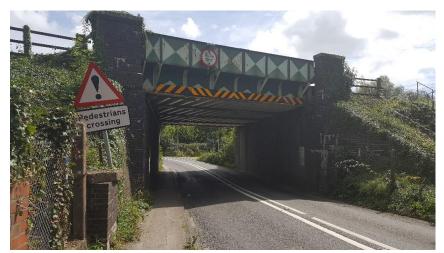
Photograph 6: Western Approach to Railway Bridge

3.1 This Chapter provides an account of the existing and proposed vertical clearances achievable at Allbrook Railway Bridge. The existing arrangement is demonstrated in **Photographs 6** and **7**.

3.2 The aim of this Chapter is to provide an account of the existing constraints which have led to the advised height restriction of 3.7m and in turn the size of vehicles which currently are and are not able to pass under this bridge. This report then outlines proposed improvements to the horizontal and vertical alignments of the road under the bridge which could be delivered as part of the Eastleigh SGO.

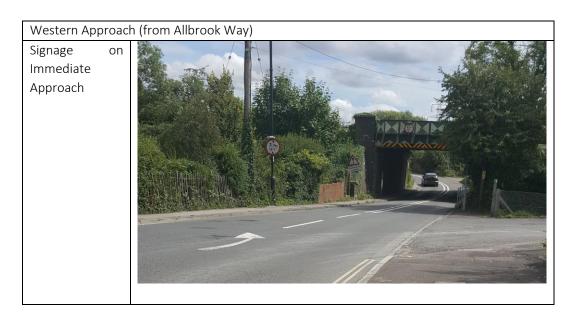
- 3.11 A review of the existing signage on approach to the low bridge has identified the following existing provision:

Signage on Allbrook Way/ Allbrook Hill Roundabout

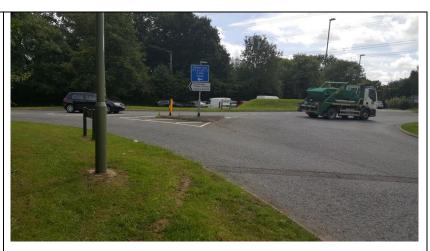
Signage on Pitmore Road

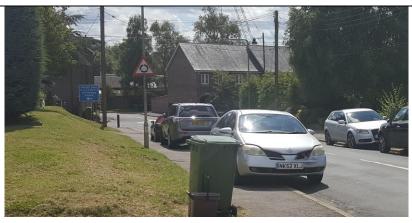
Eastern Approach (from Highbridge Road)

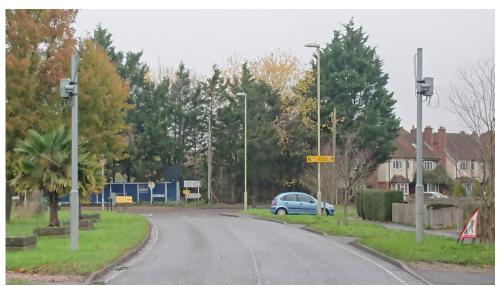
Photograph 8: Infra-red Sensor at Malmesbury Road, Romsey

3.27 A second option would be to install infra-red sensors on the new bypass route at the height restriction of the bridge, so as if the vehicle passes through the beam (i.e. the beam is 'broken'), warning systems are triggered. The warning systems could include either visual (VAS) or audible warnings. An example of an infra-red sensor is demonstrated in **Photograph 8**, with this photograph taken at Malmesbury Road in Romsey on approach to the Greatbridge Road Railway Bridge.

3.28 The proposed bypass route and adjoining side roads provide opportunities to successfully implement such a feature, locating these advanced sensors on the Allbrook Hill bypass with the ability for oversized HGVs to divert onto Pitmore Road. On the eastern approach, there is currently no opportunity for larger vehicles to turn, but an HGV turning route is proposed as part of the realigned Highbridge Road design, connecting back to the current Highbridge Road alignment as shown in Appendix G.

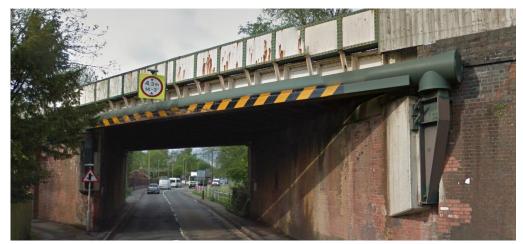
Photograph 9: Protective beam at Greatbridge Road, Romsey

3.29 Furthermore, protective beams could also be used to protect the structure of the bridge. There are different types of beam ranging from a full reinforced concrete 'steel box girder' to a smaller protective beam to absorb the energy of the impact. Alternatively, similar beams can be constructed away from the bridge, so that if a high vehicle strikes this structure the bridge itself is not impacted. An example of a protective beam is demonstrated in **Photograph 9**, with this photograph taken from the railway bridge at Greatbridge Road, Romsey.

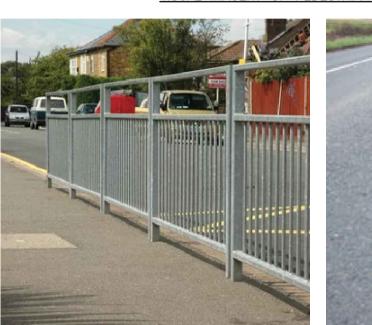
OPTION 1/2 - PEDESTRIAN GUARDRAIL

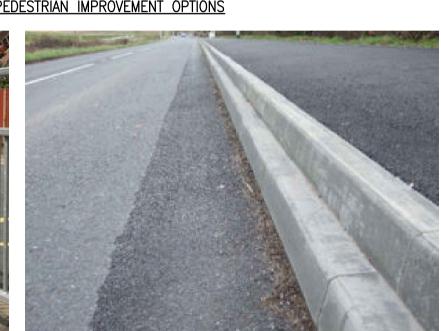
OPTION 3 - DOUBLE STACKED KERBS
