Highbridge Road / Itchen Navigation Bridge Replacement Options

Bridge Concept Report
A-093273

Highwood Group / Galliford Try Partnerships
June 2018
Prepared on behalf of WYG Engineering Limited

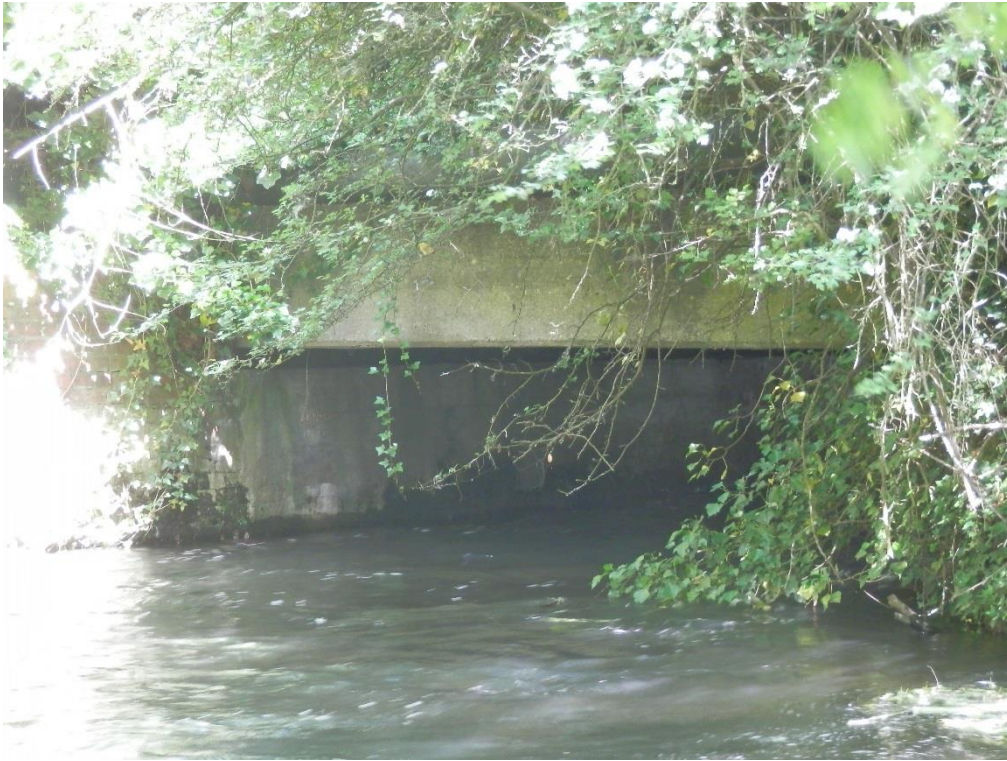
Photograph 5 View of the South elevation of the bridge

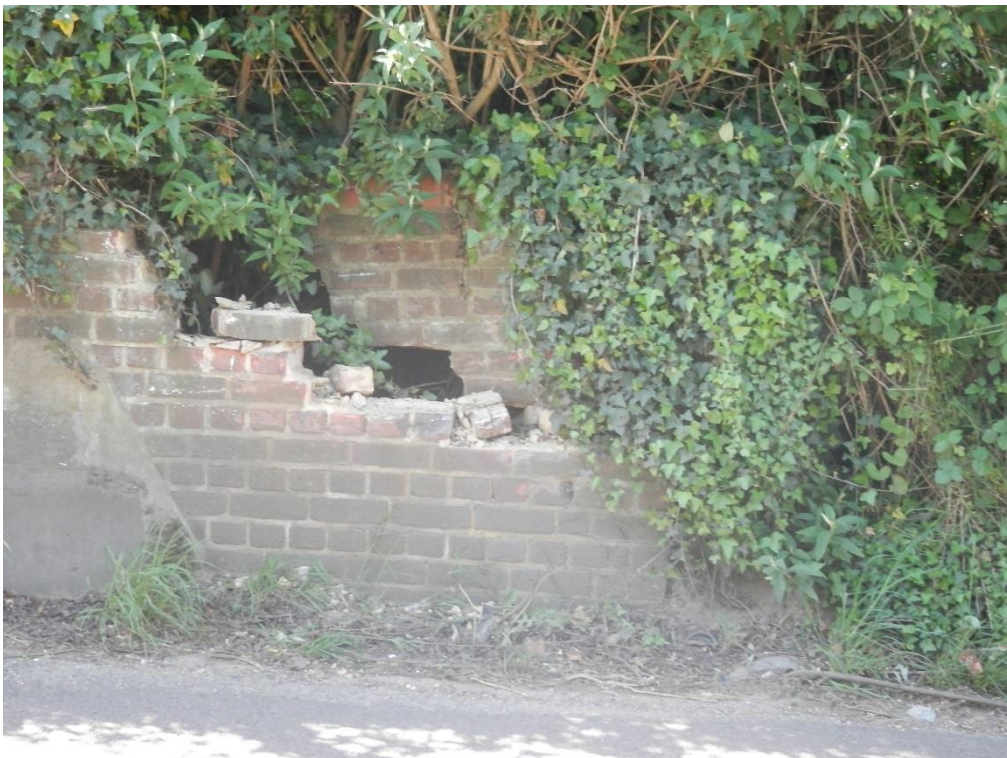
Photograph 6 Cracking/separation of the South West parapet, assumed due to vehicle impact

Brickwork parapets are provided to both sides of the road, with openings to provide access to the towpath between the main watercourse and the drainage channel. Areas of extensive damage were noted to the parapets as shown in Photograph 6. This is likely to be the result of vehicle impact(s).

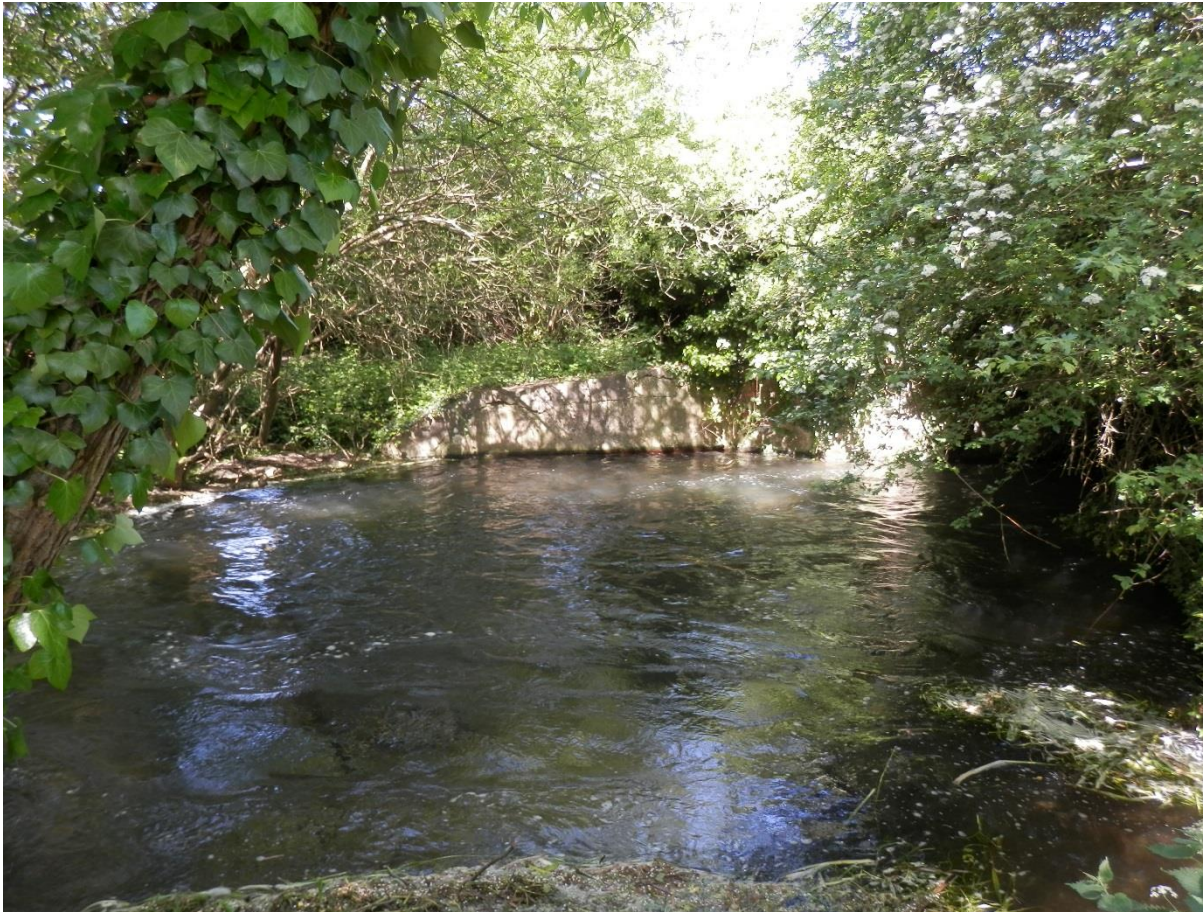
Photograph 7 View of the concrete extension to the South West wing wall looking along the approximate line of the proposed new structure.

The South West wing wall has been extended in concrete as shown in Photograph 7.

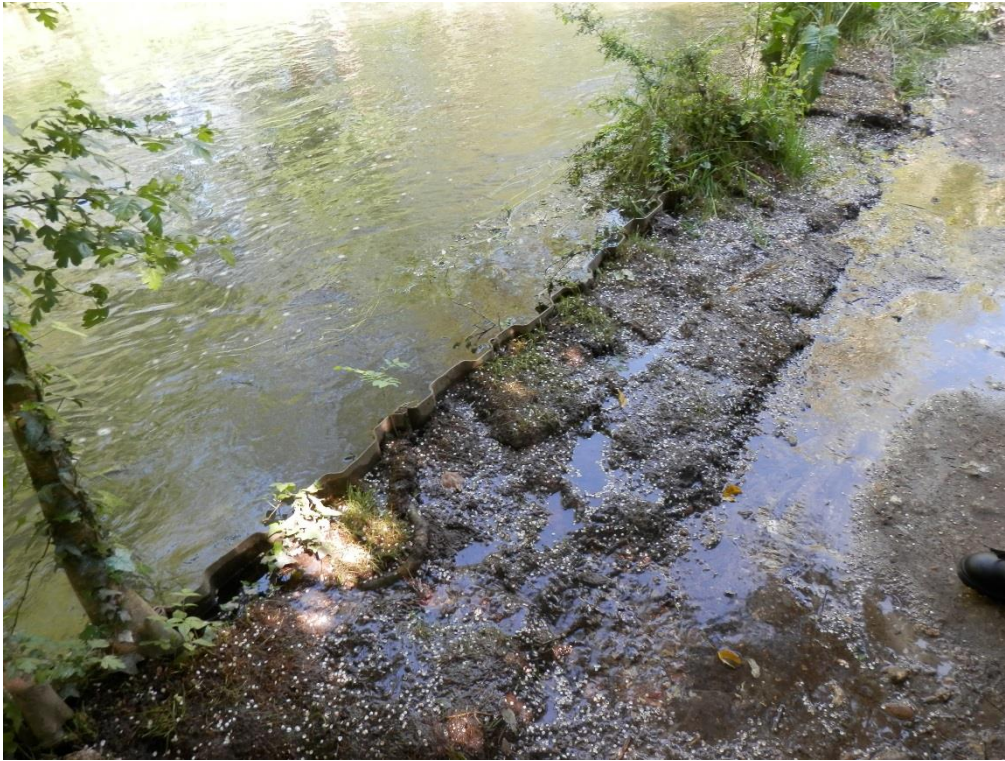
Photograph 8 Trench sheets / lightweight sheet piles forming the edge of the tow path to the south of the bridge

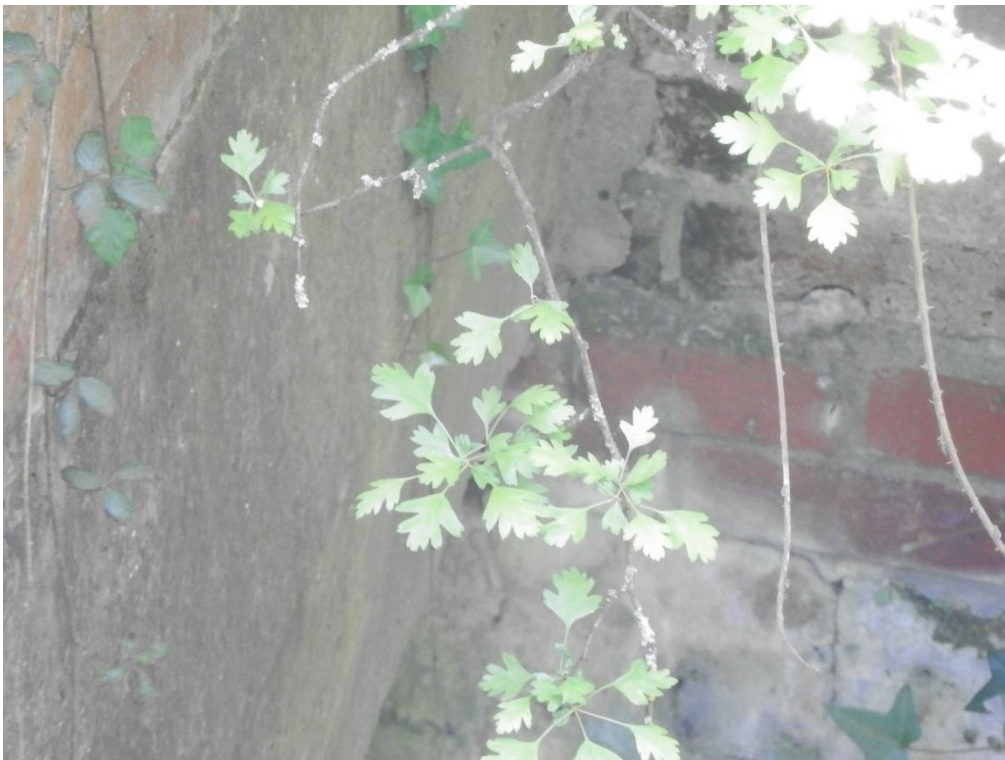
Photograph 9 Brickwork abutment at the North west corner of the bridge

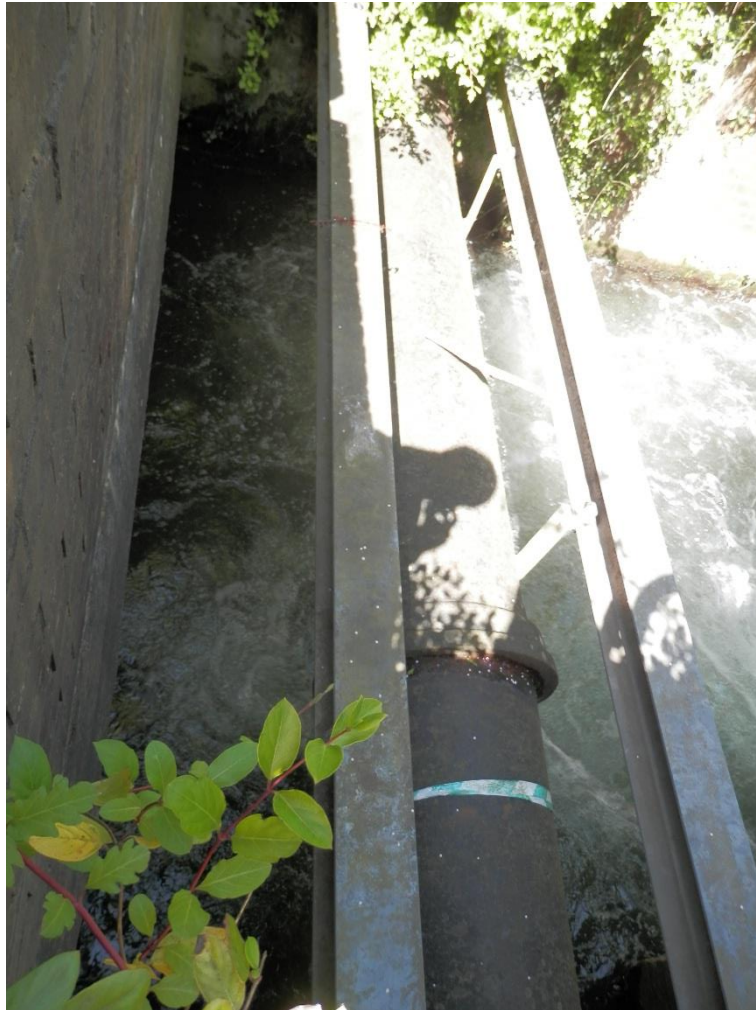
Photograph 10 Pipe bridge to the North of the existing bridge

A pipe, noted to be "2'-0" dia. main" on the location plan record drawing, is noted to be present to the North of the bridge. The pipe is supported off to sections and it is independent of the bridge structure other than the fact it is built off the same abutments.

The available drawings show at least one service passing over the bridge. A pipe bridge supporting, what appeared to be, a water main was noted to the North of the existing bridge, as shown in Photograph 10. The pipe bridge is structurally independent of the existing bridge although it shares the bridge abutments.
